State of Wisconsin Government Accountability Board

Top 10 Polling Place Accessibility Problems Explained

October 2013

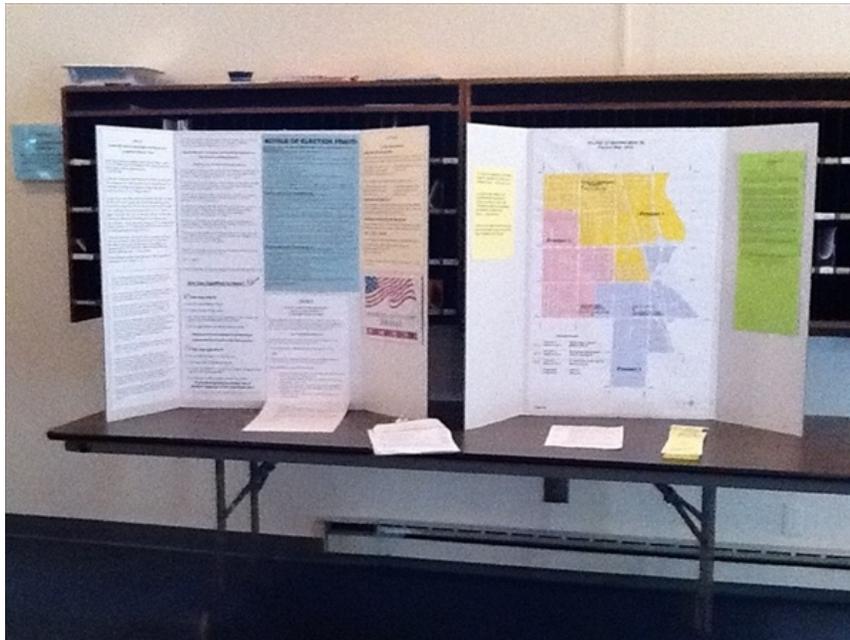
(figure 1)

Required forms, notices and ward maps can be printed in the required font and mounted in an orderly fashion on cardboard for display (figure 1). After each election, the display can be stored for continued use. This practice ensures that required election materials are present for each election. A corkboard can also be used for this same purpose (figure 2).

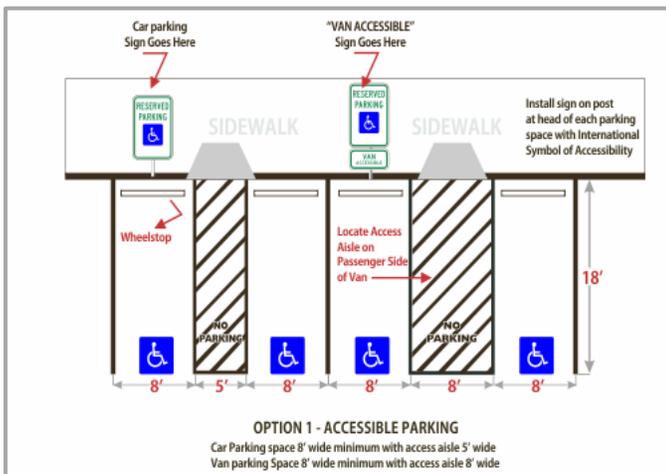
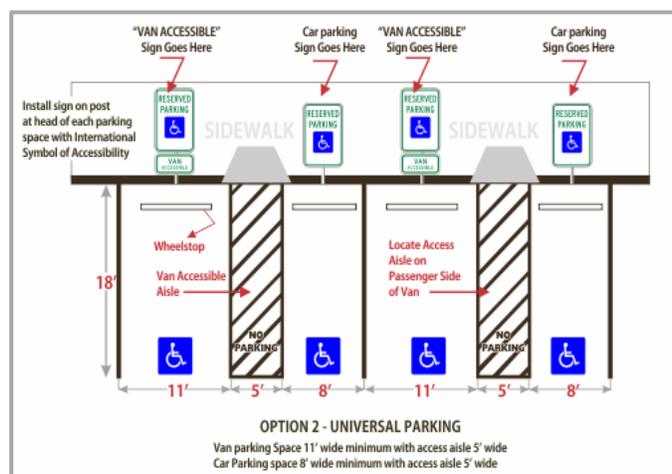
A Van-Accessible parking space should at least 8 feet wide with an adjacent accessible aisle that is also at least 8 feet wide. Regular accessible spaces should also be 8 feet wide, but need only 5 foot wide accessible aisles. Accessible spaces that meet standards for Universal Design should be 11 feet wide with 5 foot wide accessible aisles (figures 2 and 3).

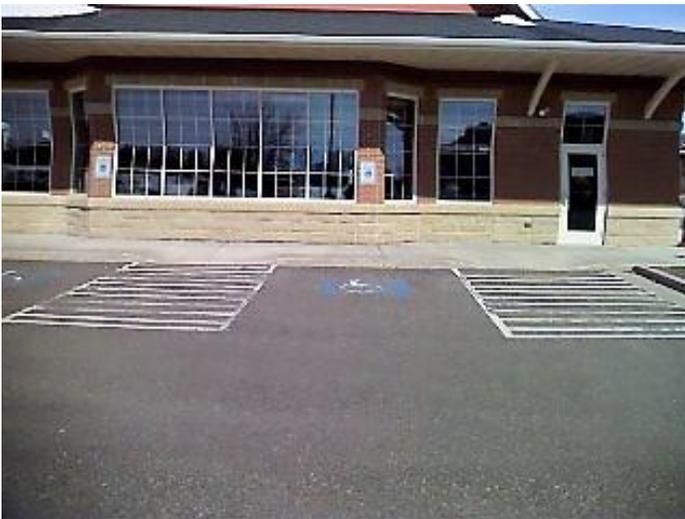
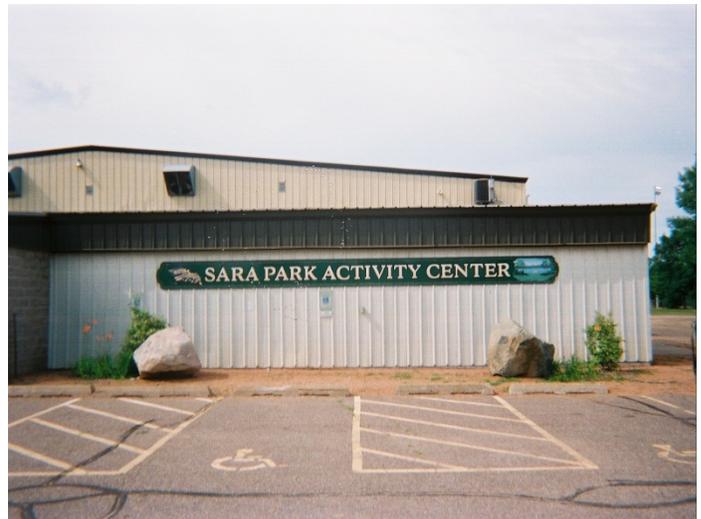
These facilities (figures 4 and 5) are examples of off-street parking areas with good accessible parking layouts. These locations have multiple spaces that meet the size requirements with proper signage posted. These parking areas are paved with asphalt and the spaces are located closest to the accessible entrance allowing a voter with a disability to travel the shortest distance from the parking area to the entrance.

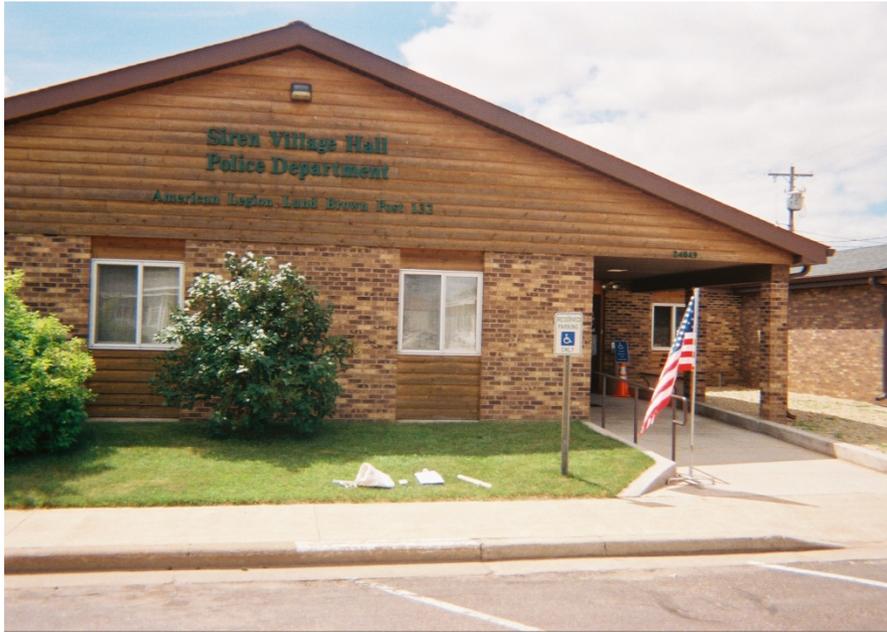
(figure 6)

The facility pictured in figure 6 is a good example of proper accessible parking for locations with only on-street parking. There is one properly-signed space available that is located adjacent to the accessible pathway leading to the entrance. Notice that a curb cut is provided to ensure access from the street to the pathway.

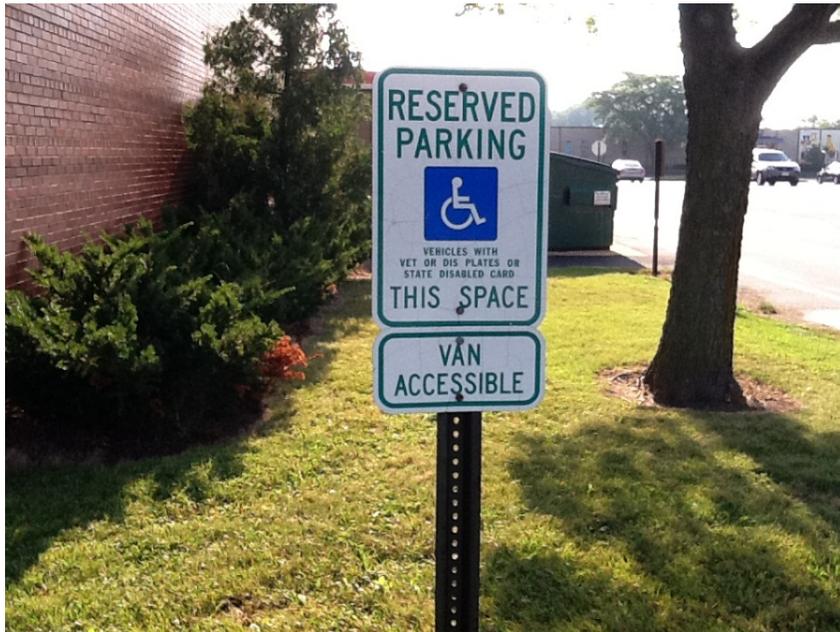
(figure 7)

Below you can see an example of a proper Van-Accessible sign (figure 7). The accessible parking sign has the universal symbol of accessibility and the additional signage for Van-Accessible spaces is present.

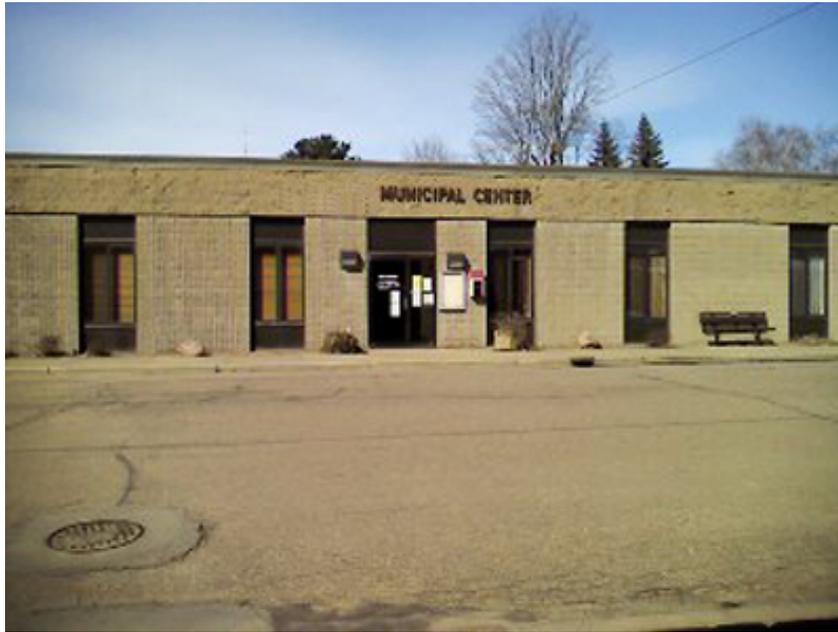
(figure 8)

Many voting locations do not have spaces reserved for voters with disabilities in the parking area. The facility shown below has no marked accessible parking spaces located closest to the accessible entrance.

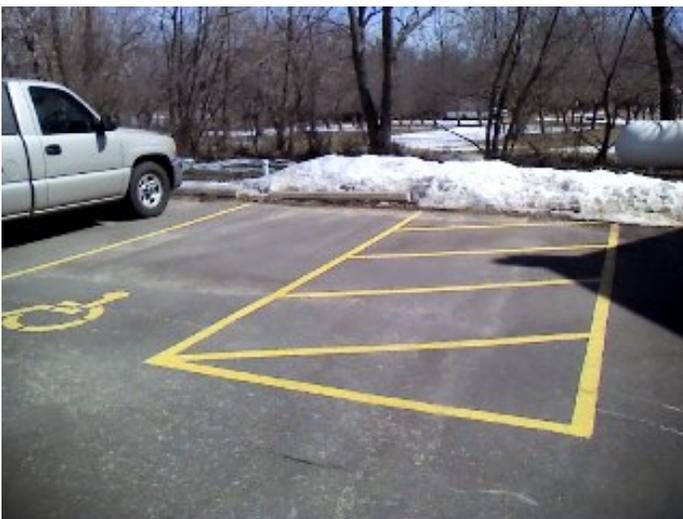
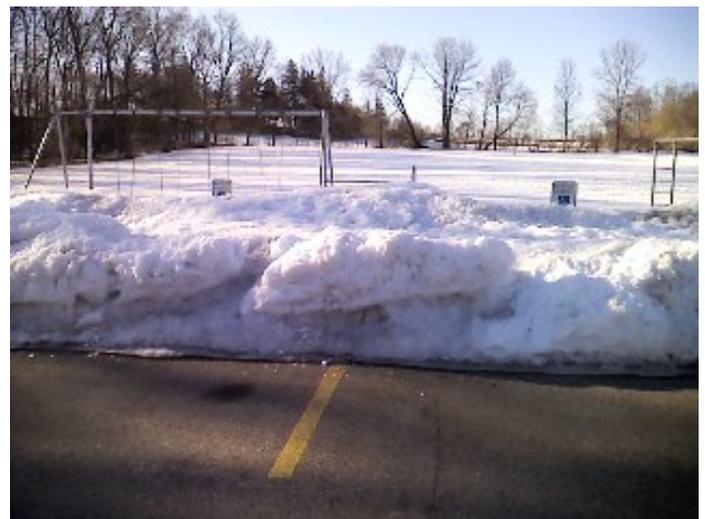
Many parking areas have accessible spaces that are only marked on the ground. The ADA requires that all accessible parking spaces have signs posted between 60" and 80" above the ground. Accessible parking spaces without signs posted above ground (figure 9) and accessible parking signs that are not posted at the required height (figure 10) can become obscured by a vehicle parked in the spot or by snow during the winter months.

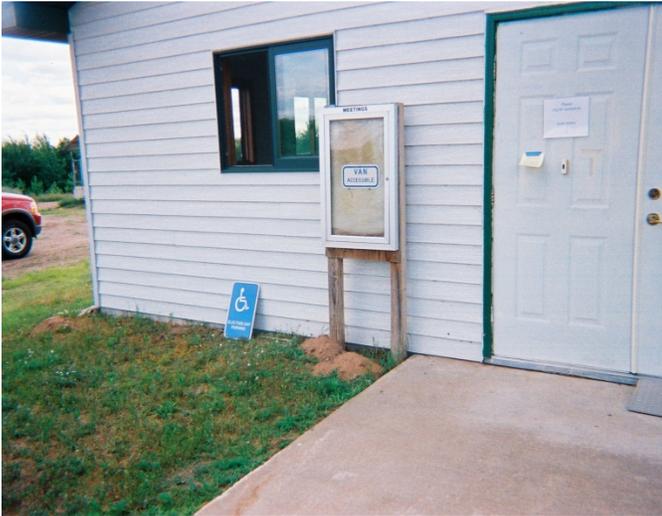
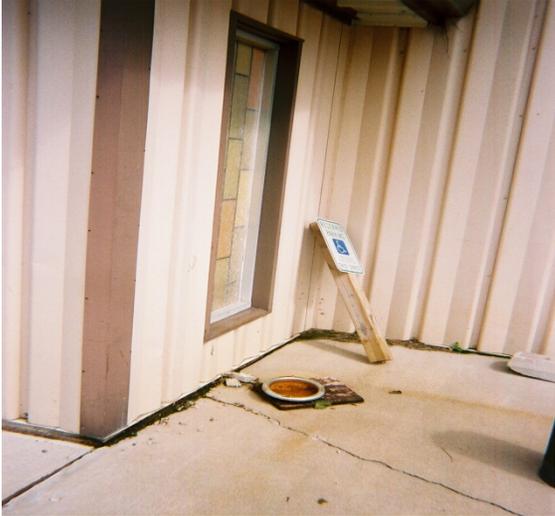
Signage should always be mounted to a post or pole or affixed to the side of a building. It should never be placed leaning up against the side of a building and should be replaced if damaged or uprooted (figures 11 and 12).

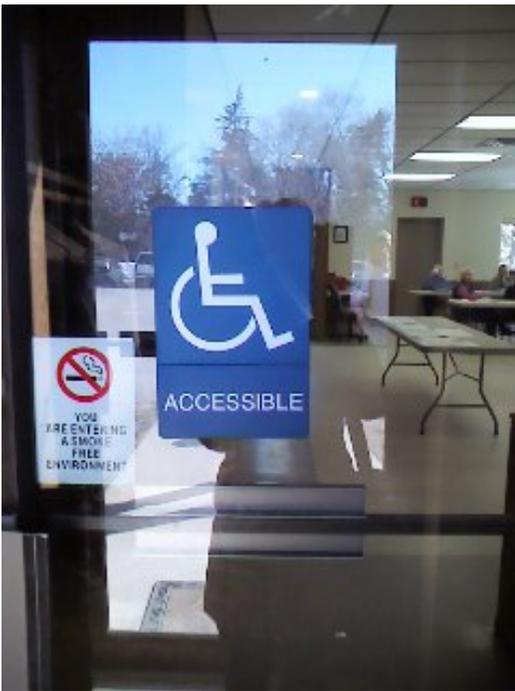
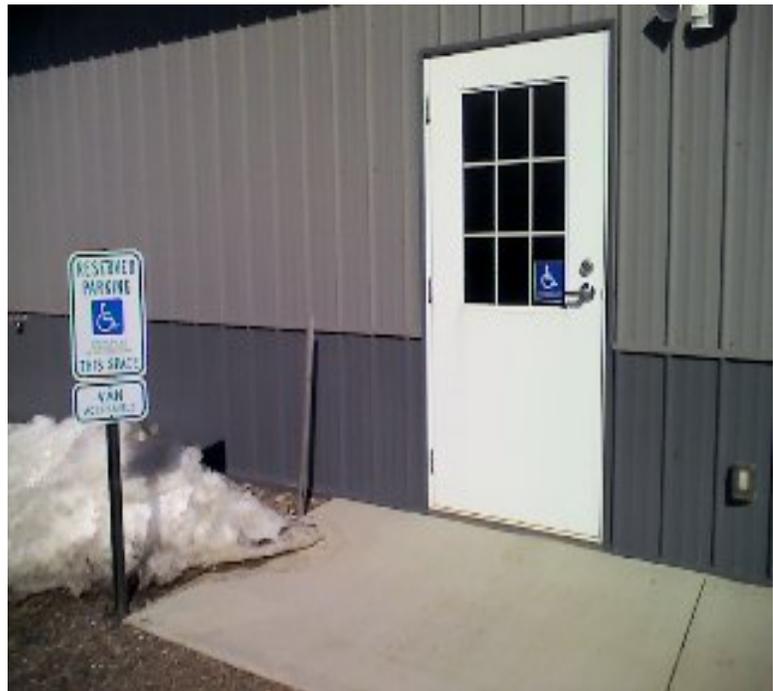
Accessible entrances can be identified using a window decal or sign like the examples found below (figures 1 and 2). If a municipality does not own the facility where a polling place is located, a reusable or temporary sign can be displayed for Election Day.

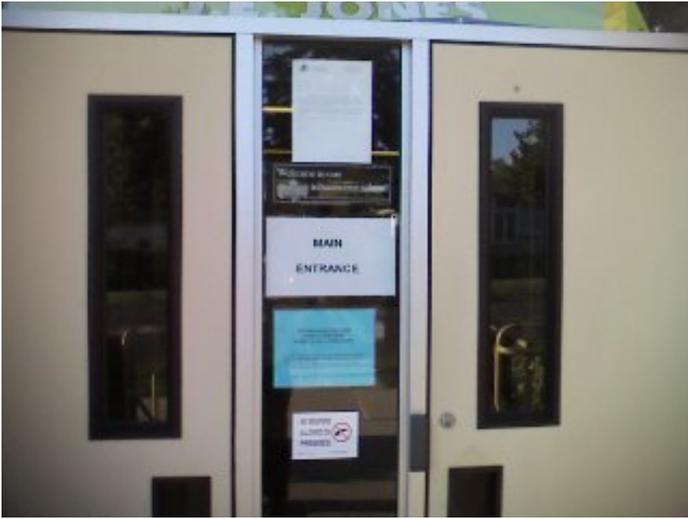
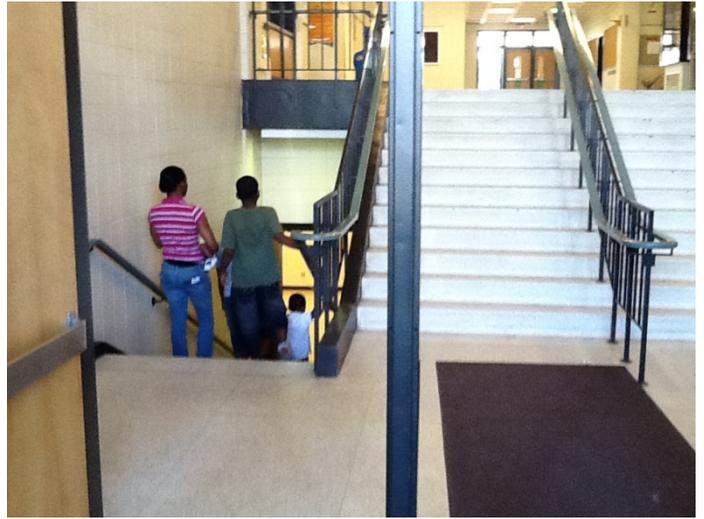
Entrances that are not properly identified can be problematic for voters, especially at facilities that have multiple entrances and voting areas that are not located directly inside of the accessible entrance. The below photos depict doors that are not properly marked as the accessible entrance (figure 3) and an unmarked entrance that, upon entry, requires a voter to navigate stairs (figure 4).

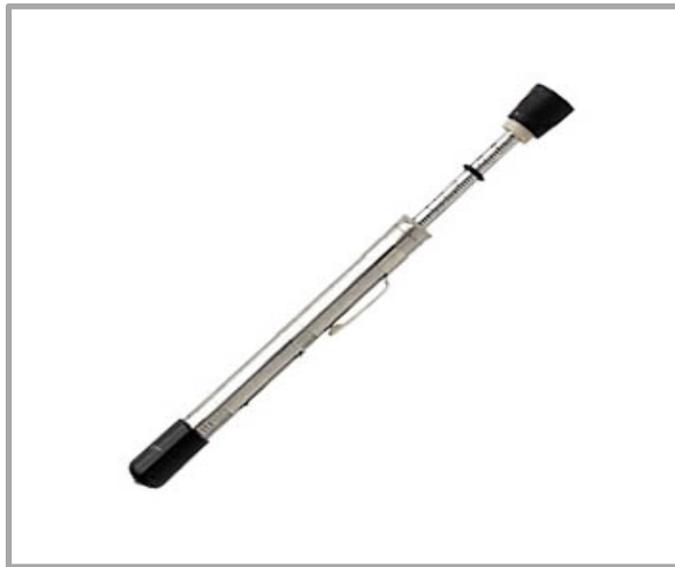
(figure 1)

All doors at the accessible entrance and along the interior route should be tested to see if they meet ADA standards. This can be done using a door pressure gauge like the one pictured below (figure 1). Doors that require too much pressure to open should be adjusted accordingly.

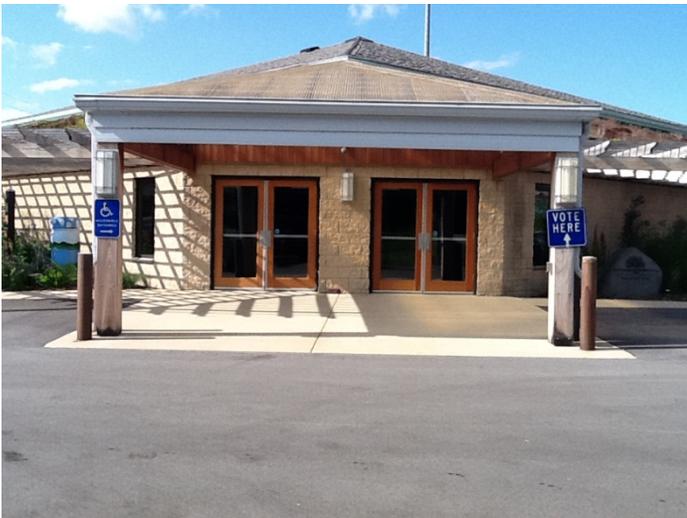
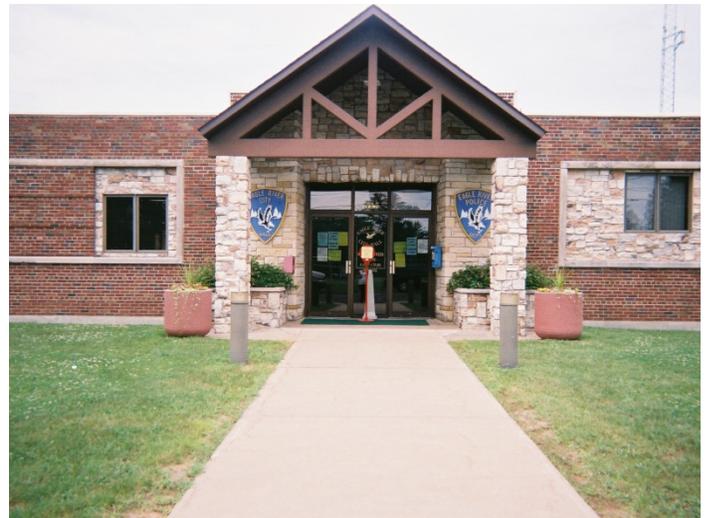
The two facilities pictured below both have accessible pathways that meet ADA standards. Both pathways are wider than the required 36” and are made of concrete. In addition, the below left facility (figure 1) has an accessible pathway that is level with the parking area and does not require a visitor to the facility to navigate a curb cut or pathway ramp to reach the accessible entrance. Both pathways also do not have any objects on or above the pathway that would create an impediment for a voter.

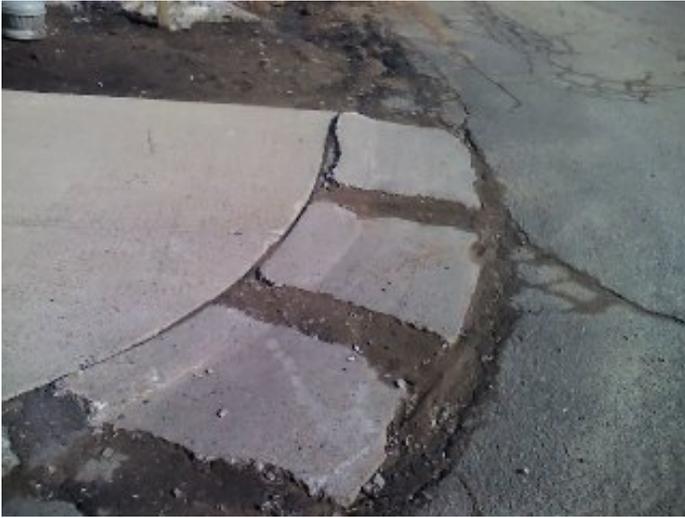
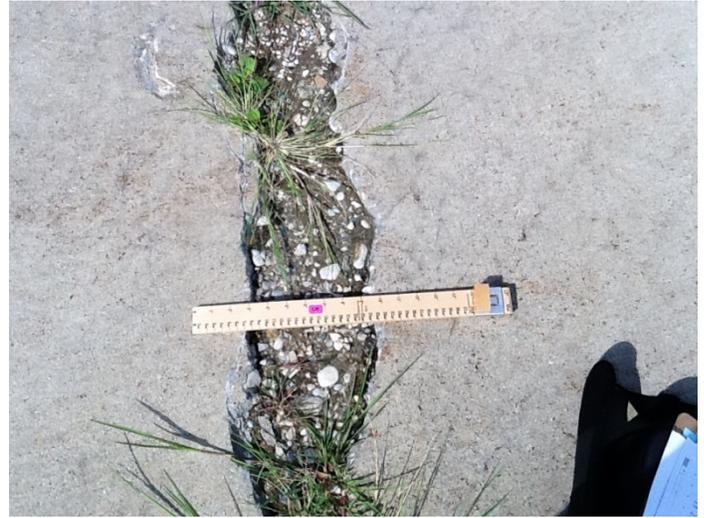
Accessible pathways with large breaks or cracks in them create hazards for voters who use canes, walkers or wheelchairs. Pathways that have segments with a height difference of over ½ inch also represent a tripping

hazard for all voters, especially those with mobility issues. These height differences can be caused by tree roots growing under the pathway or by damage from snow and ice during winter.

All breaks and cracks over ½ inch in size should be filled in or repaired. Pathways with significant height differences can be shaved or ground down to fix the problem. If there is extensive damage to an accessible pathway, the only remedy may be to replace the pathway or relocate that accessible parking area to a location where an acceptable pathway can be used to provide access to the accessible entrance of the facility.

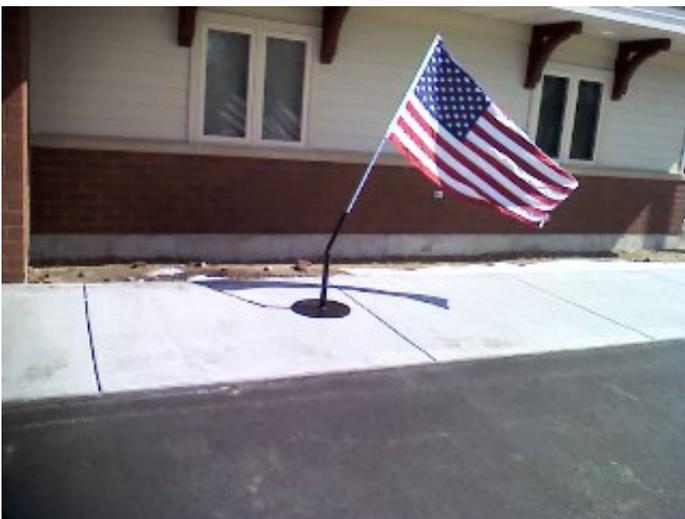
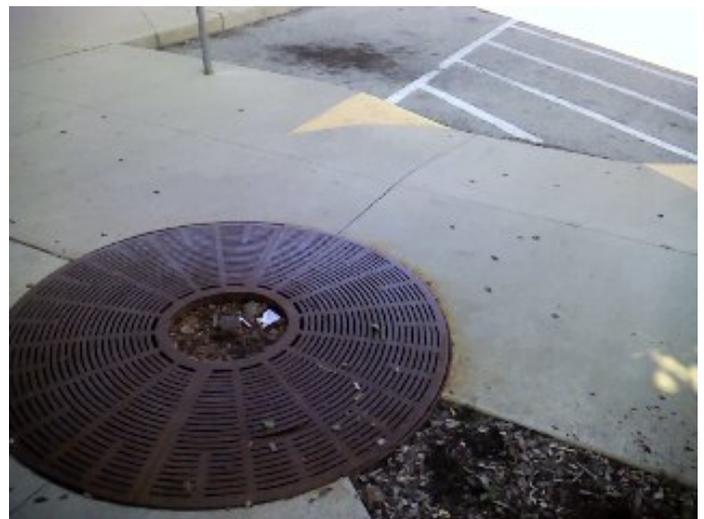
Obstacles, such as the flag pictured below, should be removed or placed in a location that does not create a hazard for voters using the accessible pathway (figure 5). Grates should also be covered so that they do not create difficulty for voters who use walkers, canes or wheelchairs (figure 6).

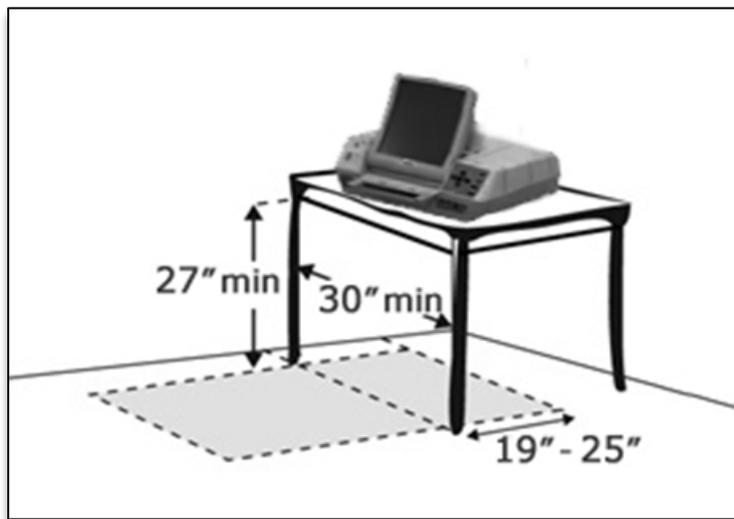
(figure 1)

The entrance to the table should be at least 30" wide and the height from the floor to the underside of the table must be a minimum of 27". The top of the table or writing surface must be no higher than 34" and there should be at least 19" of knee/toe clearance under the table so that a voter in a wheelchair will have access to the top of the booth or table/writing surface. Please note that the table in the above diagram is pictured with an accessible voting machine on top of it, but the same standards apply to the booth or table where a voter with a disability can cast a paper ballot.

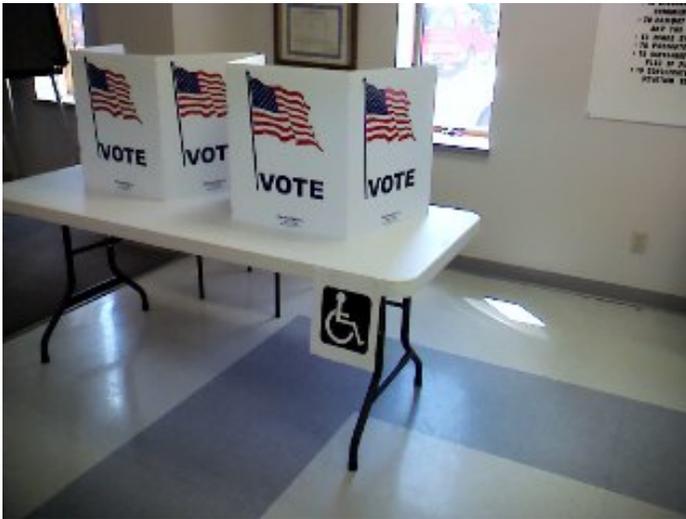
(figure 2)

Pictured below are two common practices for providing an accessible booth or table for a voter with a disability who wishes to cast a paper ballot. In the below left photo, a folding table that meets ADA standards has been set up with privacy shields on top to ensure voter privacy (figure 2).

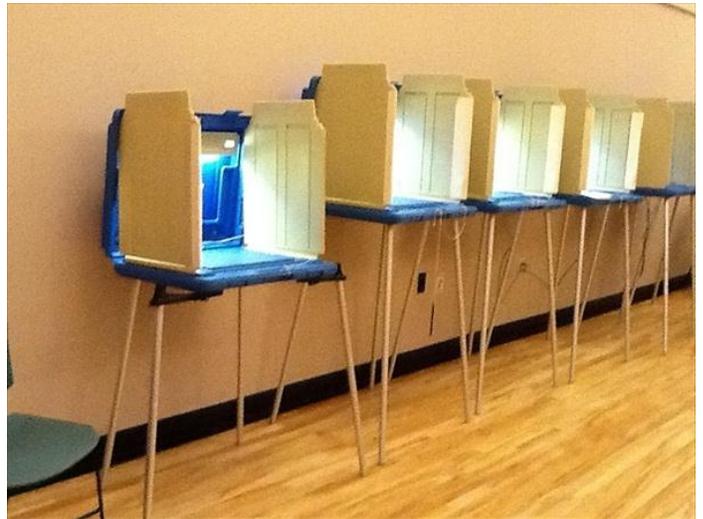
(figure 3)

Many municipalities use ADA-compliant voting booths like the one shown in the below right image. These booths are similar to regular voting booths, but are lower to the ground and have a wider entrance to provide access for voters in wheelchairs. The accessible voting booths also afford the same degree of privacy as regular voting booths (figure 3).

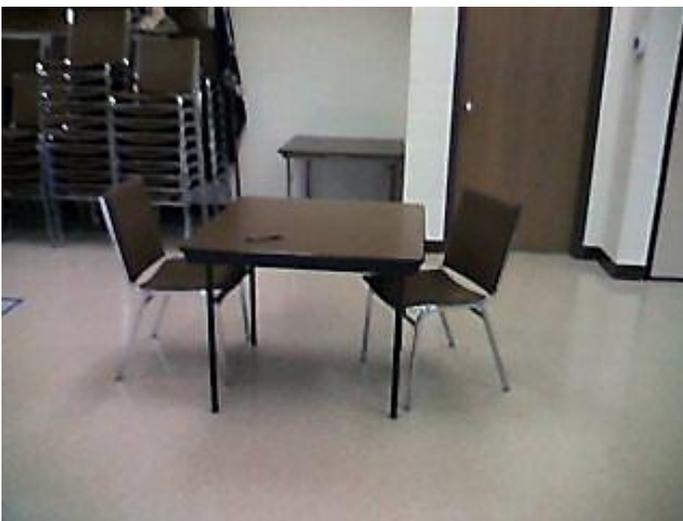
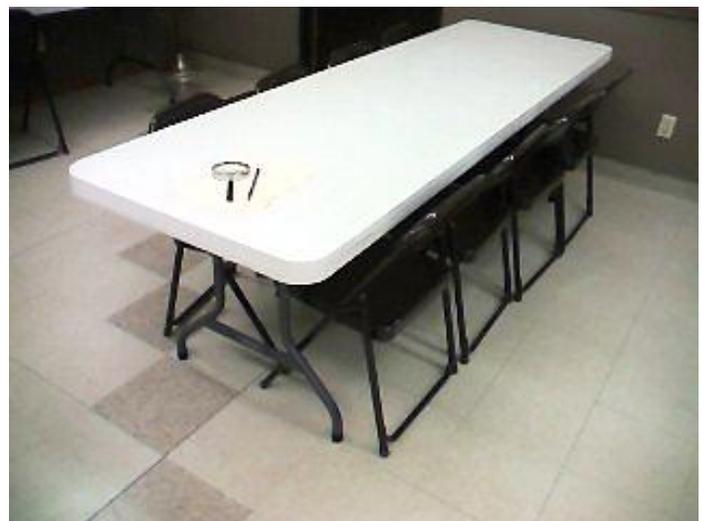
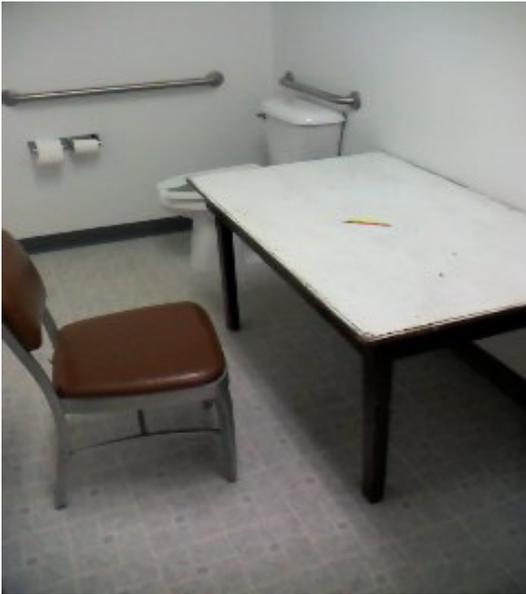
Both of the tables pictured below do not provide privacy for voters using them to cast a paper ballot. The table pictured in the below right photo does have a magnifying glass to assist voters with vision problems, but lacks a privacy shield (figure 5). In addition, those materials are placed on the table in a location that would not provide the full 19" of knee/toe clearance due to the presence of the table legs and support bars.

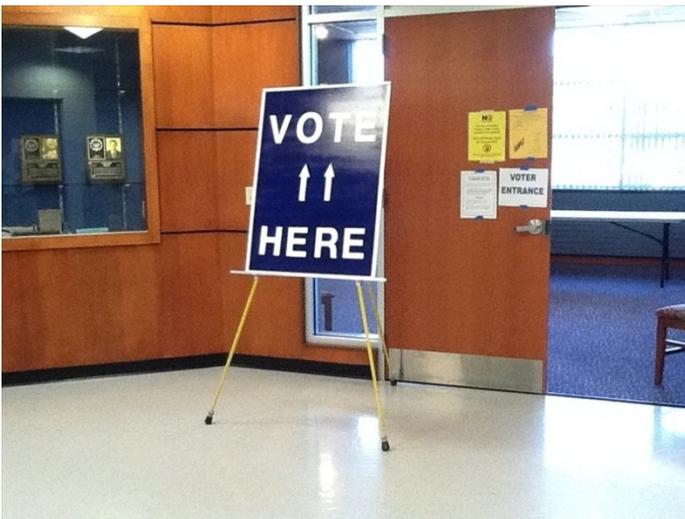
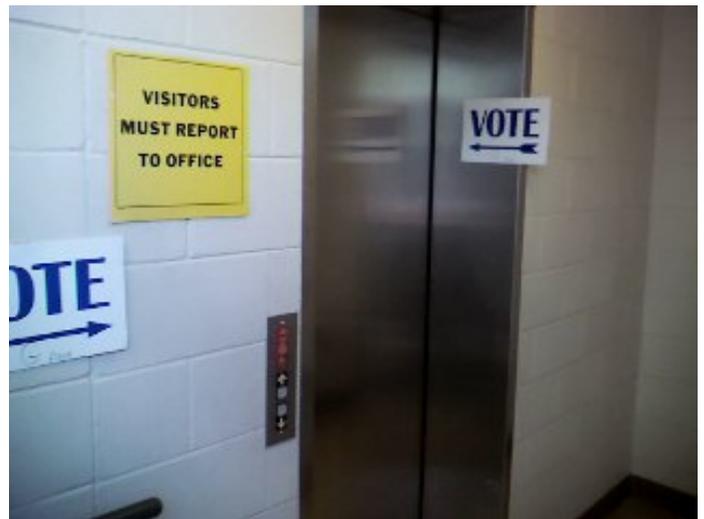
All interior routes from the accessible entrance to the voting area should be marked with large print signs directing voters to the voting area. The sign pictured in the below left photo allows voters to identify the voting area without confusion (figure 1). In the below right photo, directional signs are used to direct voters to the elevator that they would need to use to access the voting area (figure 2).

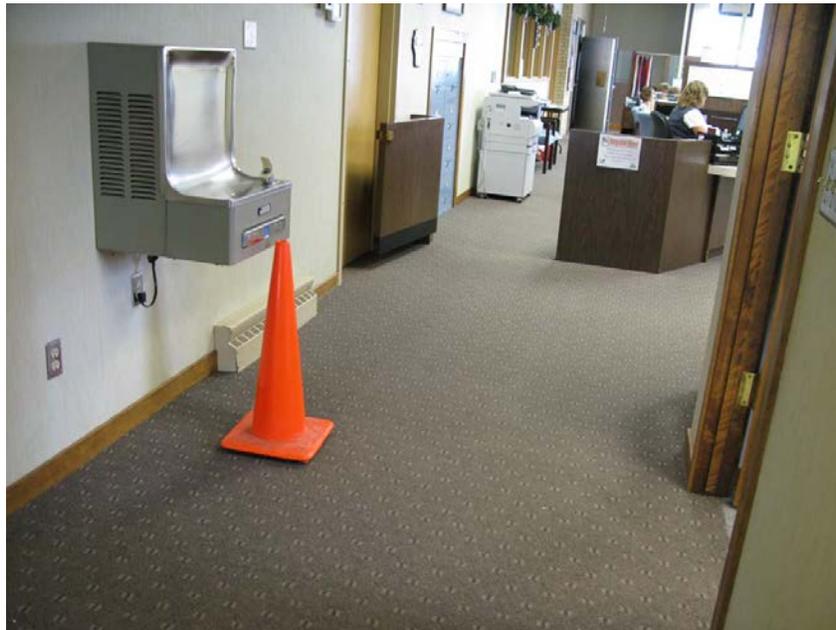
(figure 3)

The below photo illustrates the proper method for marking a permanent or semi-permanent obstacle along the route to the voting area (figure 3). The traffic cone allows voters with visual impairments who use a cane to detect the obstacle and move around it.

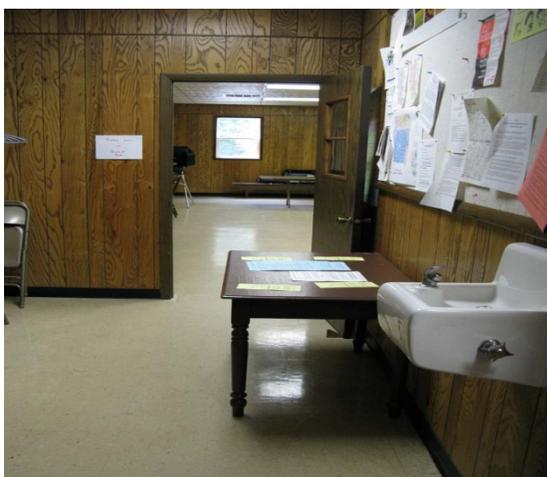
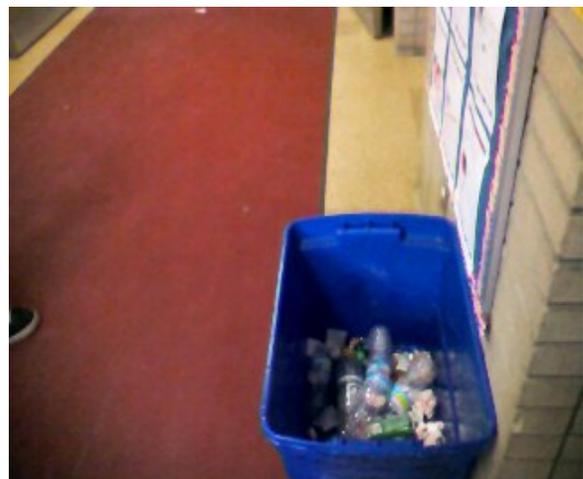
Pictured below are examples of obstacles that should either be removed or marked with a cane-detectable barrier on Election Day. The below right photo (figure 5) illustrates that objects such as recycling bins and trash cans should be removed from corridors and hallways that voters will use to access the voting area, while the photo on the below left (figure 4) depicts a table that restricts access to the voting area and a drinking fountain that should be marked with a cane-detectable barrier, but is not. These barriers can be eliminated during a quick walk thorough by the municipal clerk, or another election worker, on or before Election Day.

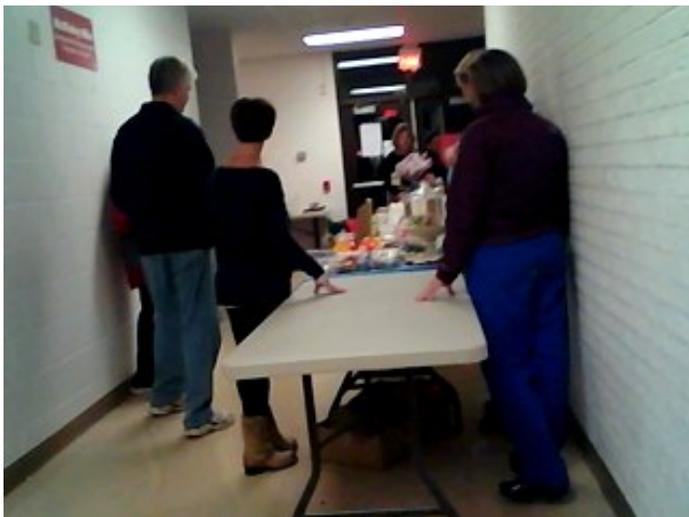
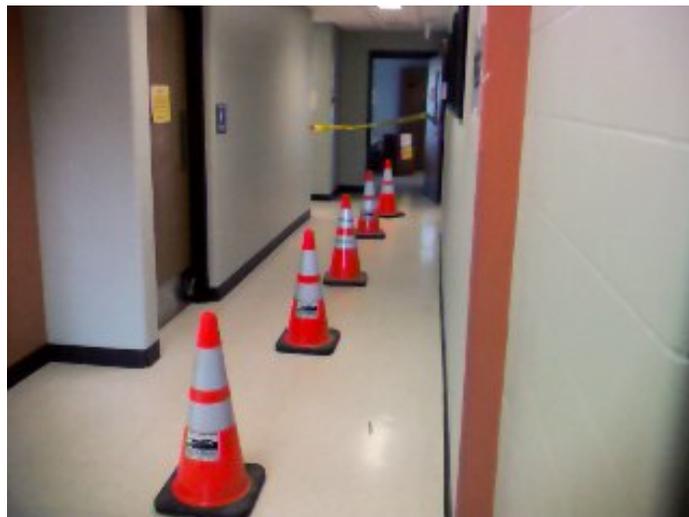
The below photos represent situations where the set-up of a polling place has inadvertently created accessibility issues. The use of traffic cones in the below right photo (figure 7) was an attempt to create orderly flow of voters in and out of the voting area, but instead created a corridor that would not allow a voter in a wheelchair to enter the voting area without moving the cones. In the below left photo (figure 6), the tables that have been set up in the hallway create a congested path of travel that narrows for a significant distance. These situations also illustrate how polling place set-up for efficient voter flow interacts with accessibility standards.

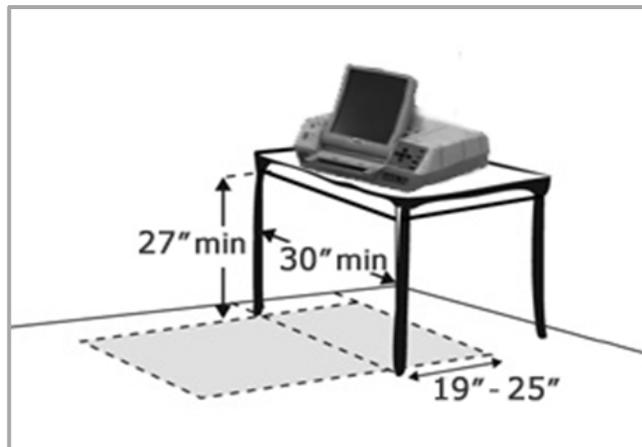
(figure 1)

Accessible voting equipment should be set up on a table or stand that meets ADA guidelines. The entrance to this table or stand should be at least 30" wide and the height from the floor to the underside of the table or stand must be a minimum of 27". There should also be at least 19" of knee/toe clearance under the table so that a voter in a wheelchair will have access to the machine.

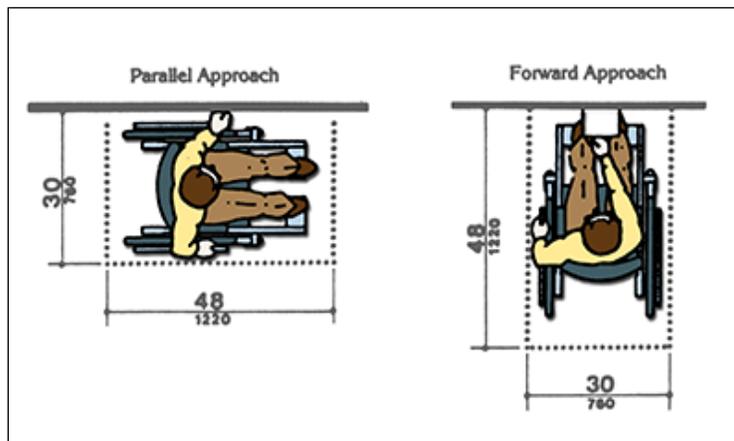
(figure 2)

In addition, there should also be at least 30 x 48" of clear floor space in front of the table or stand holding the accessible voting equipment. The height of the controls for the machine or the touch screen must be no higher than 54" for a parallel approach or 48" for a forward approach (figure 2).

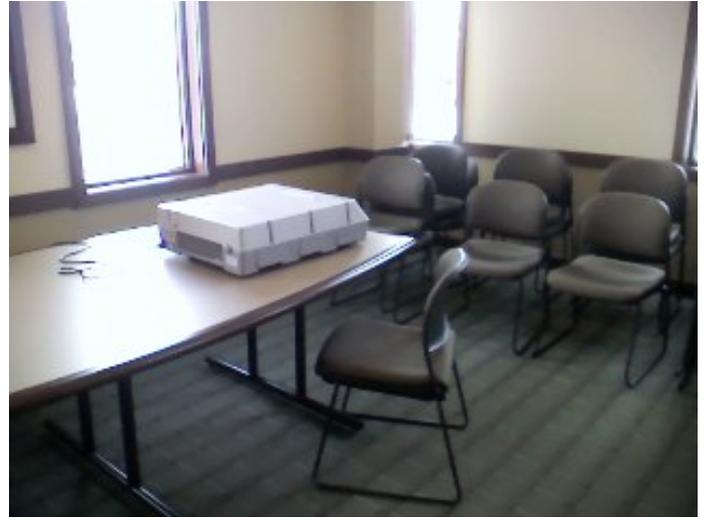
The accessible voting machine should always be set up, turned on and functioning properly on Election Day. Voters who wish to use the machine should not have to wait for an election official to set-up, plug in or insert an ink cartridge or memory device into the machine. Error messages like the one pictured below indicate that the accessible voting machine requires troubleshooting or service from a technician (figure 3).

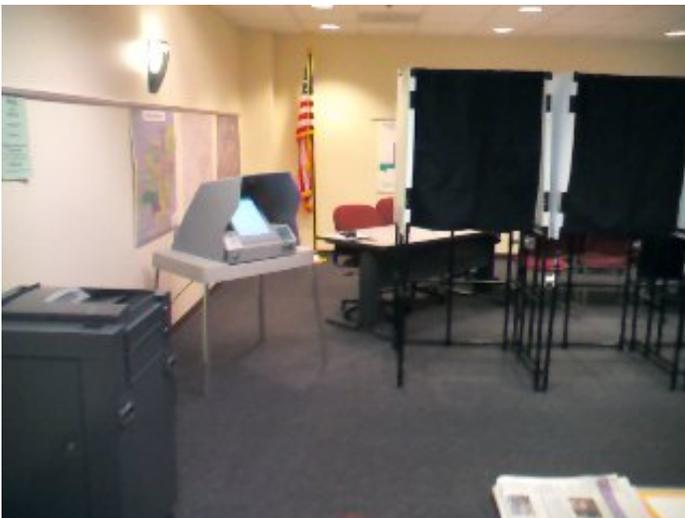
(figure 5)

Accessible voting machines should also be positioned to ensure voter privacy. The machine pictured in the below left photo has a privacy hood attached to it but is set up in a way where others could see how a voter who is using the machine was marking their ballot (figure 5).

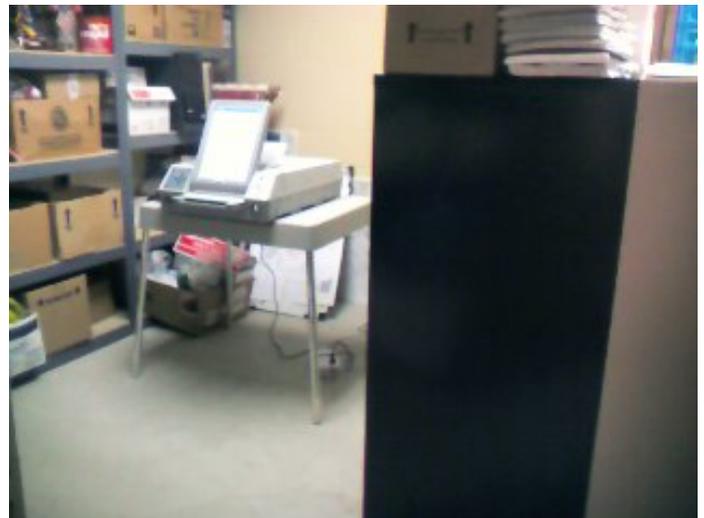
(figure 6)

The accessible voting machine should also be visible to all voters when they enter the voting area. This may be a challenge at facilities with smaller voting areas. The machines should not be located in separate rooms such as bathrooms or kitchen areas or in a location that is out of plain sight from voters, like the machine pictured in the below right photo located in the corner of a storage area behind a filing cabinet (figure 6).

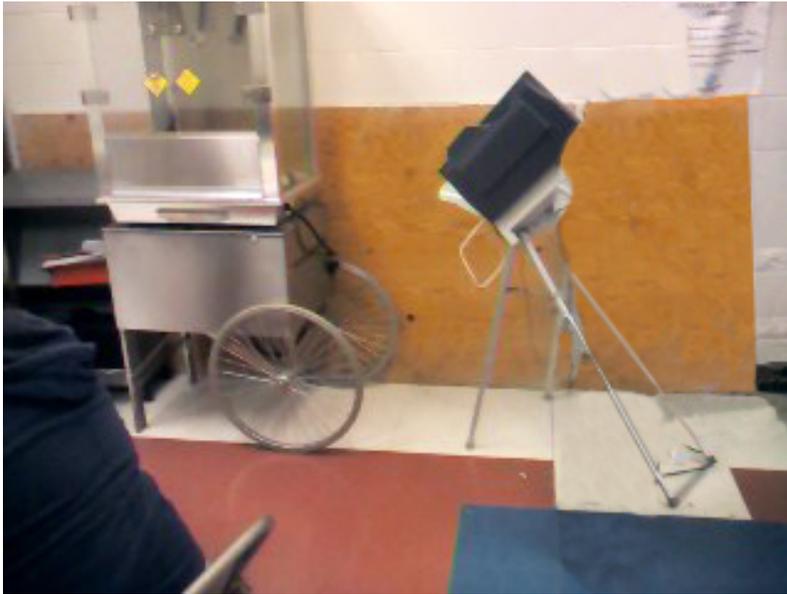
(figure 7)

Voting equipment should also be positioned with 30 x 48" clear floor space in front of the machine to ensure proper access. In the below photo, access to the machine is obstructed by the popcorn cart placed directly behind it (figure 7).

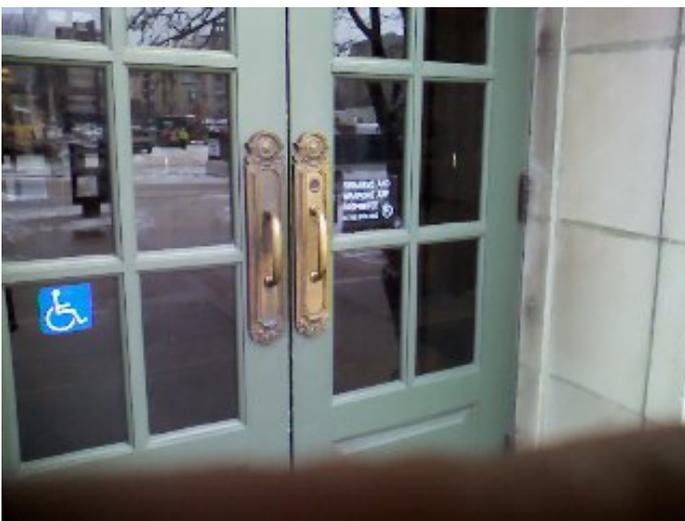
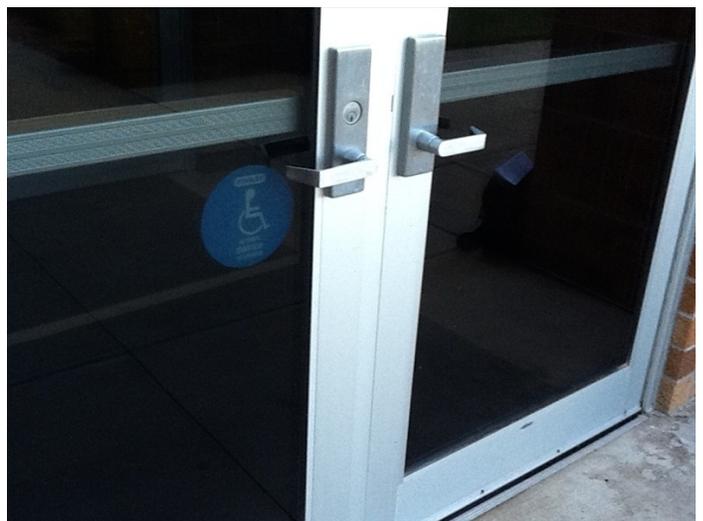
The door hardware pictured below meet the standards for accessibility (figures 2 and 3). Both types of hardware are usable with one hand without having to grab and twist the hardware to open the door.

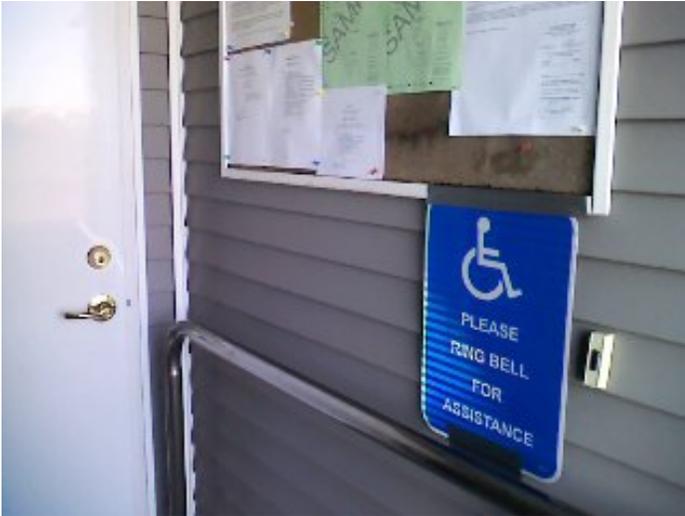
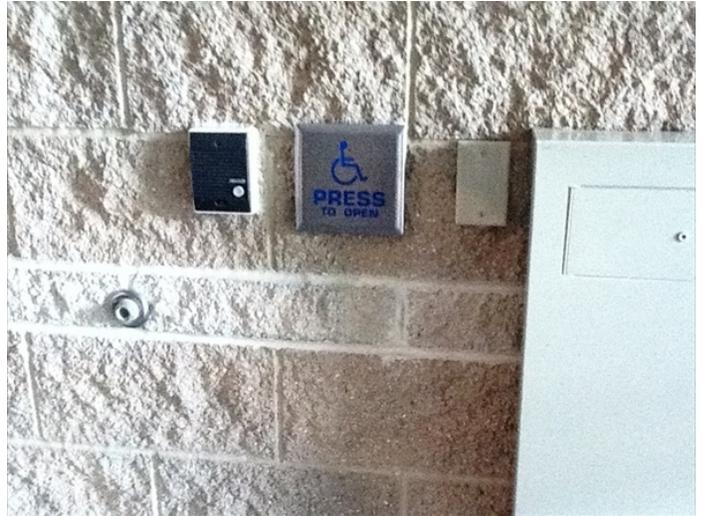
These two photos show two different electronic accessible features with the entrance on the left (figure 4) utilizing a wireless doorbell or buzzer and the door on the right (figure 5) having an automatic opener present.

If no accessible hardware or electronic feature is present, a greeter can be stationed at the door to ensure that voters who require assistance can gain entrance to the polling place and voting area.

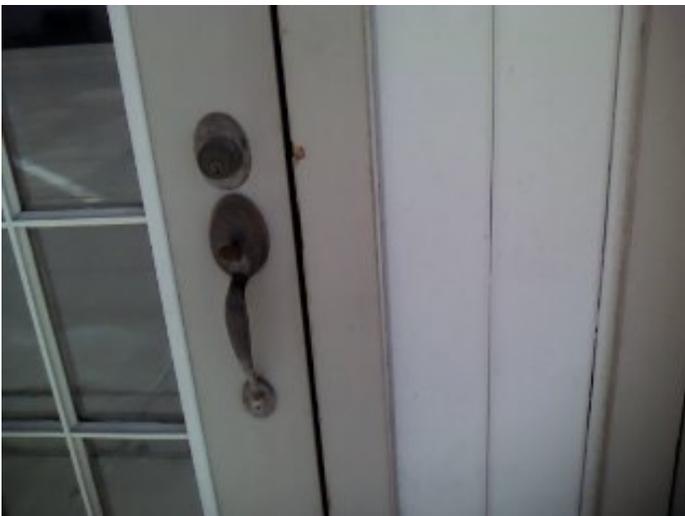
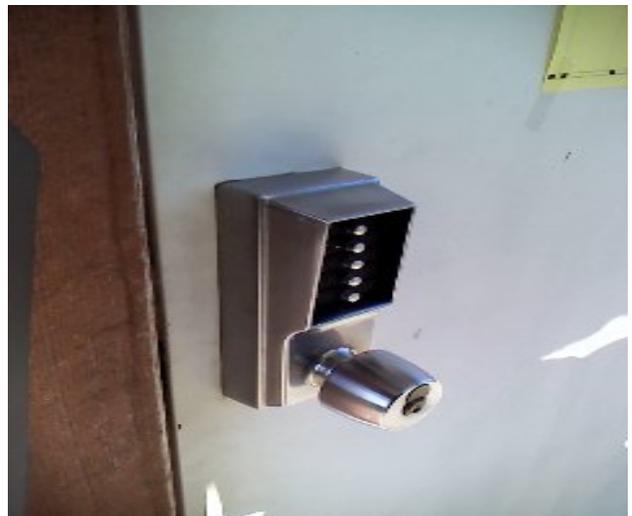
The door hardware picture below does not meet accessibility standards. The doorknob in the below right photo (figure 7) requires a grasping and twisting motion to use and the hardware on the left (figure 6) cannot be opened with one hand without tight grasping. Inaccessible hardware should be replaced or an electronic accessible feature could be installed to fix the problem. If these changes are not possible, a greeter can be stationed at the door to assist voters with entering the polling place.

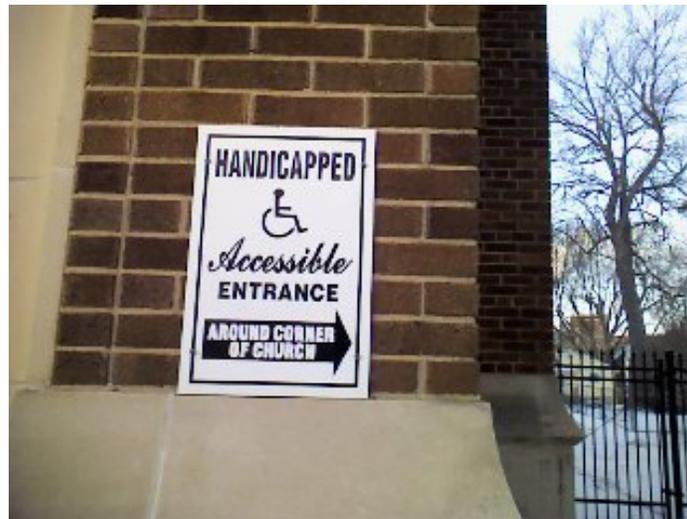
(figure 1)

The pathway from the accessible parking area/spaces to the accessible entrance should be marked with signs clearly directing voters to the correct entrance. This practice is especially important at facilities where the accessible entrance is not the same as the main entrance. Voters with mobility issues should not be burdened by entering the polling place at a point that does not provide them barrier-free access to the voting area (i.e. there should be no stairs or inaccessible doors along the route). Voters with disabilities should also not have to search for the correct entrance to a polling place.

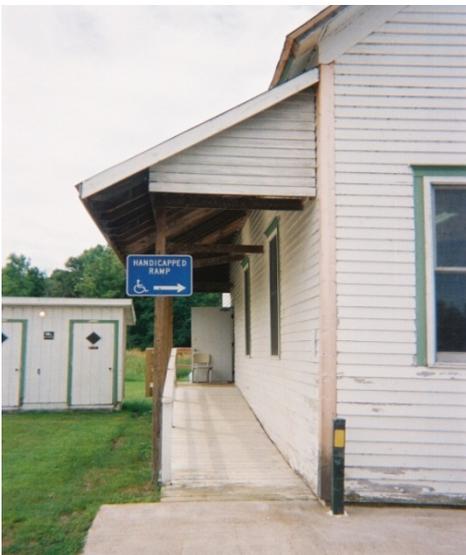
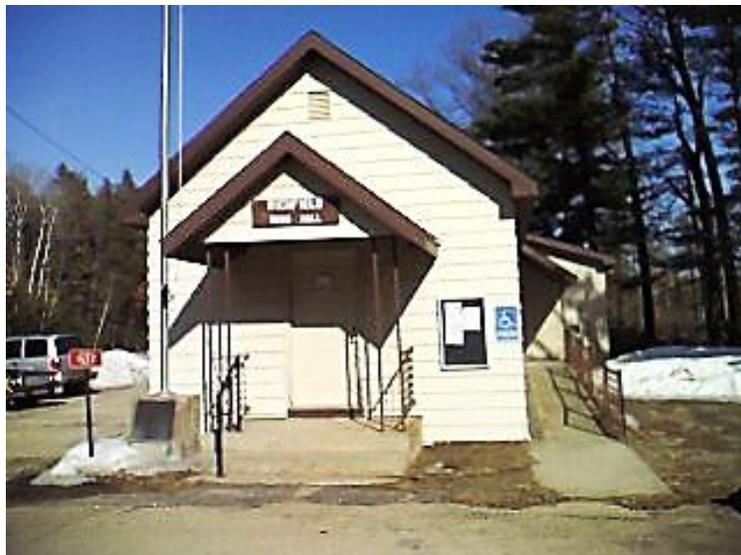
Both of the facilities pictured below have entrance ramps that provide access to the facility with signage posted directing voters to the accessible entrance (figures 2 and 3). These signs are posted high enough to be clearly visible from the parking area.
