State of Wisconsin Government Accountability Board

Top 10 Polling Place Accessibility Problems Explained

October 2013

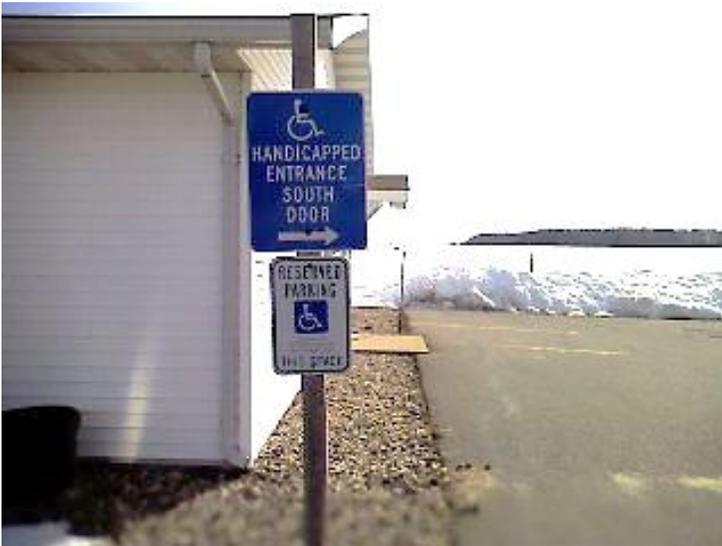
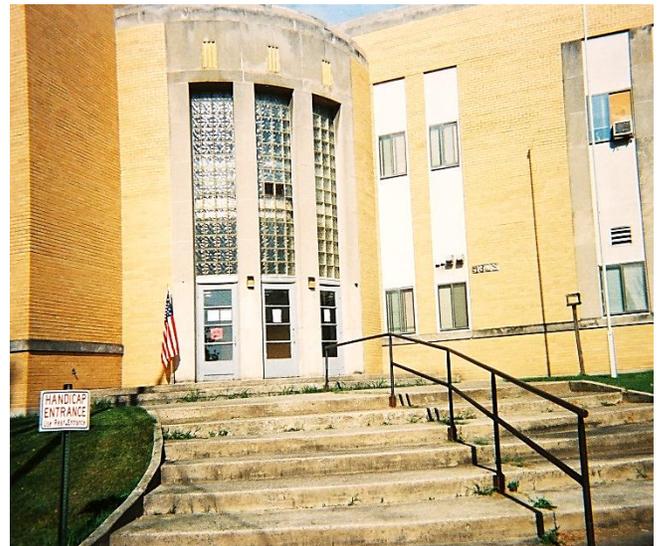
In the below left photo, the accessible entrance is identified by a sign posted in the accessible parking area, providing voters with clear entrance information in a visible location (figure 4). The facility pictured on the bottom right has a sign present at the base of the stairs providing information on the location of the accessible entrance (figure 5).
